# SSP v1.5.0

Release Note

Renesas Synergy™ Platform  
Synergy Software  
Synergy Software Package

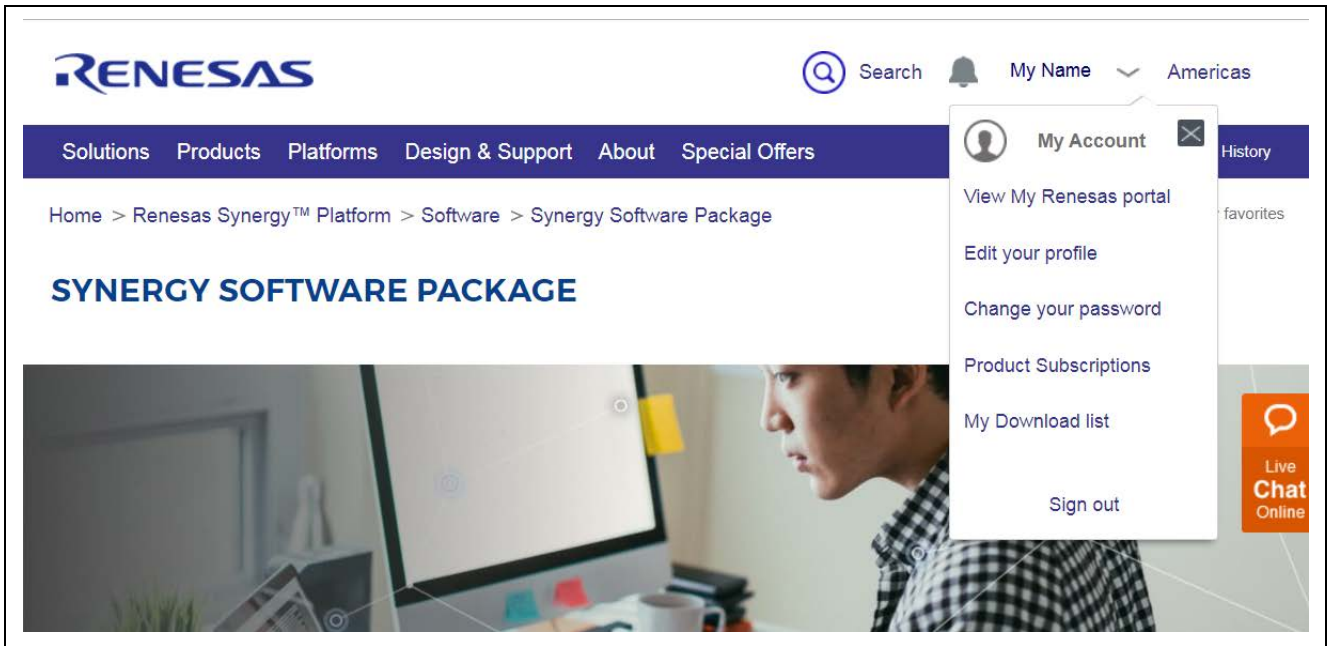
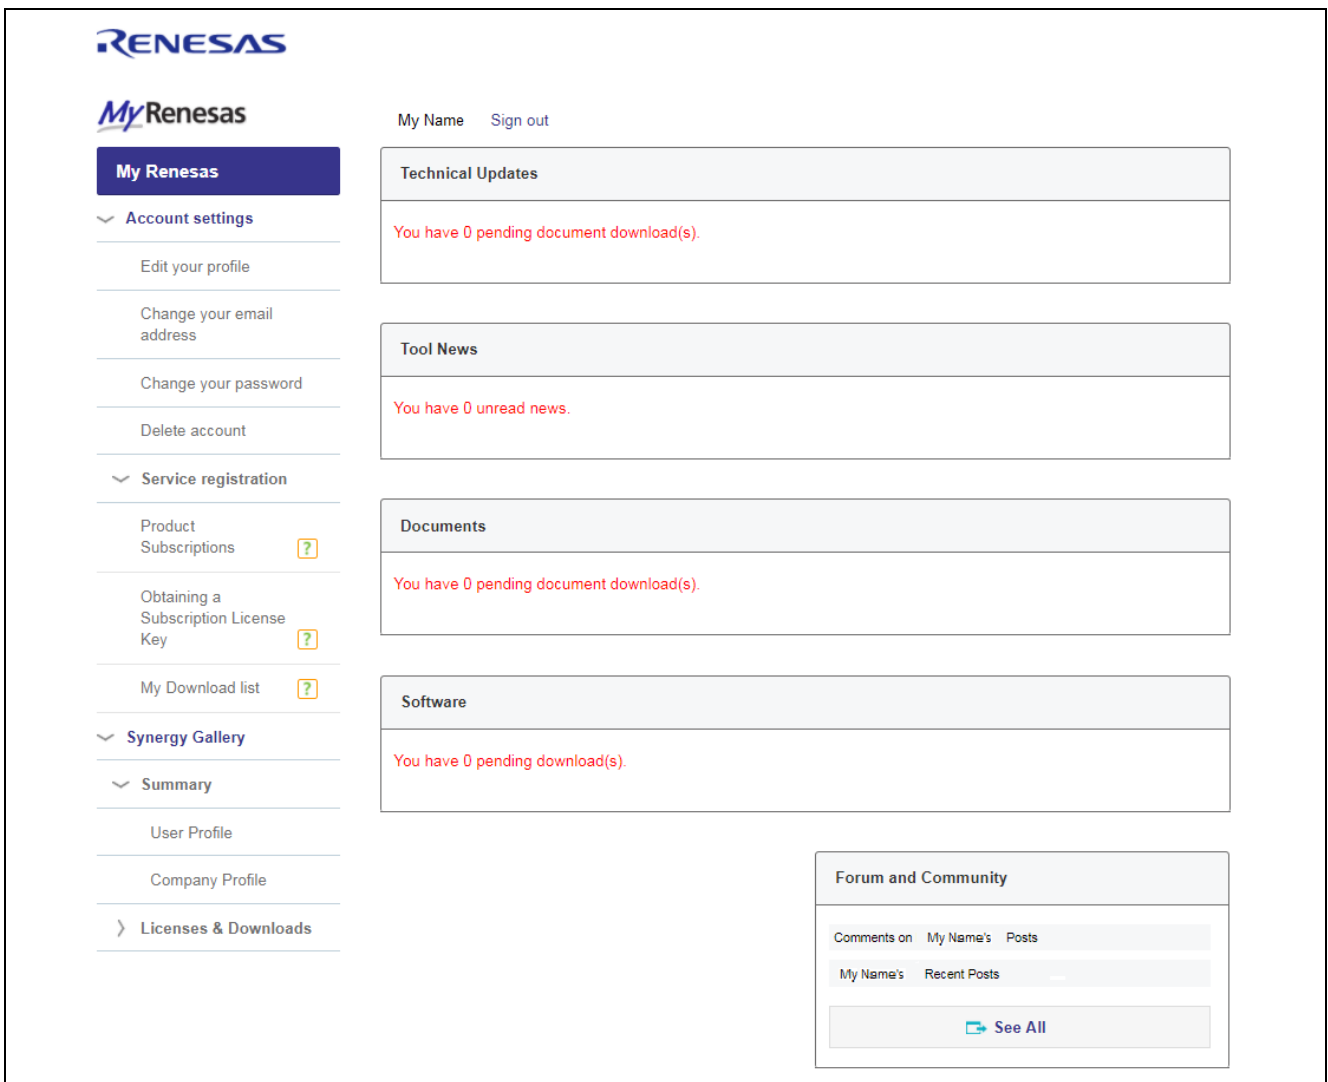
Once generated, the new License Key file can be downloaded by all users registered under that company account from the *Licenses and Downloads* section of *MyRenesas Portal* page. To access *MyRenesas Portal*, click the user name at the top of web page, then select **View My Renesas Portal** from the drop-down list as shown in the following screen captures.
